NAVAJO - BROWN VANDEVER URANIUM MINE

PRELIMINARY ASSESSMENT REFERENCES

PRELIMINARY ASSESSMENT FOR THE NAVAJO - BROWN VANDEVER URANIUM MINE

PATRICK MOLLOY  
HEALTH PHYSICIST, NAVAJO SUPERFUND OFFICE

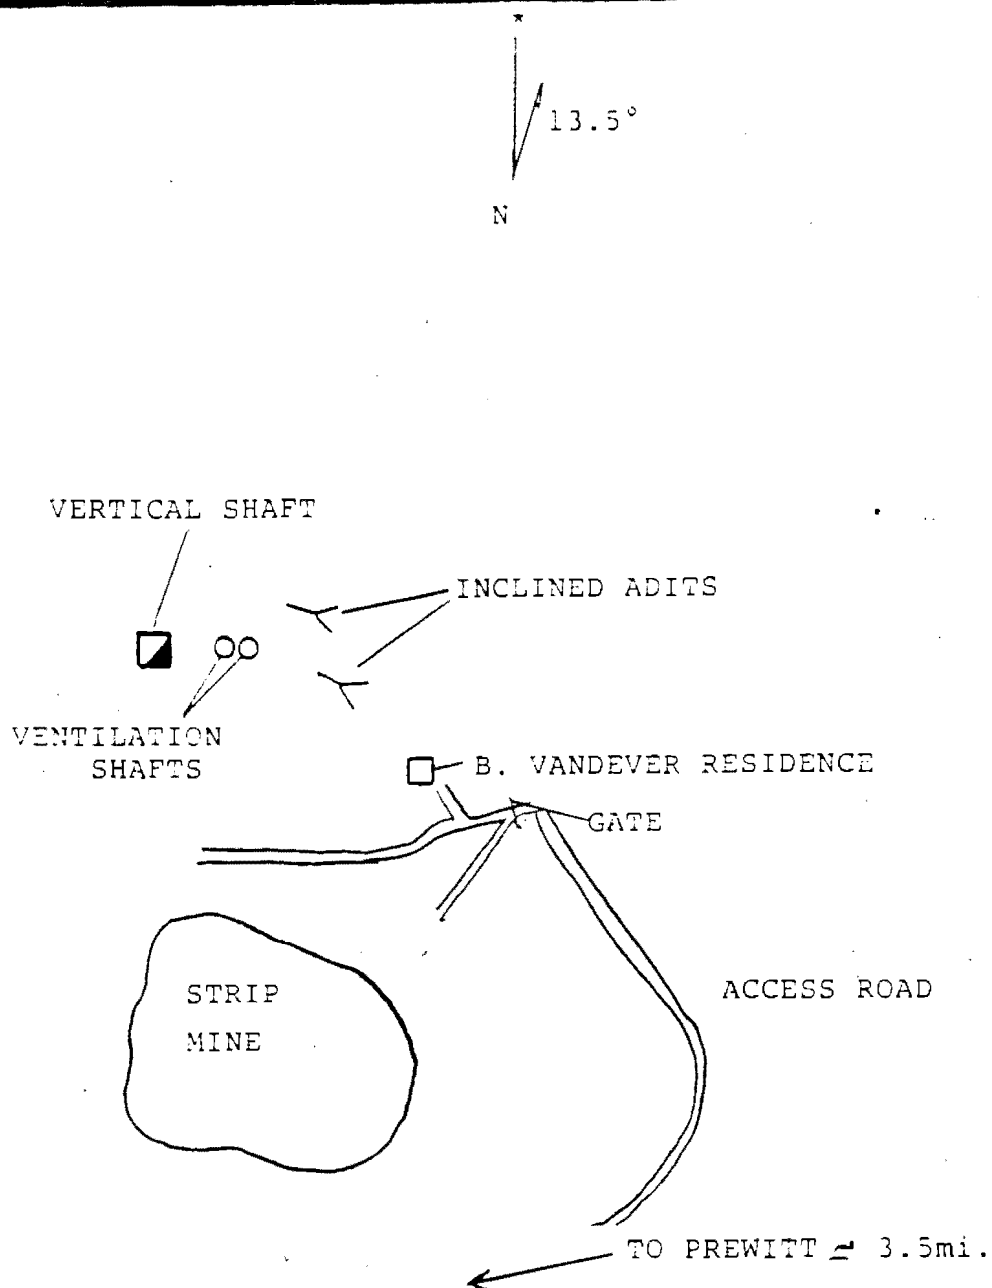
FIGURE # 4 ; SITE SKETCH

NAVAJO-BROWN VANDEV-  
ER URANIUM MINE SITE  
SKETCH

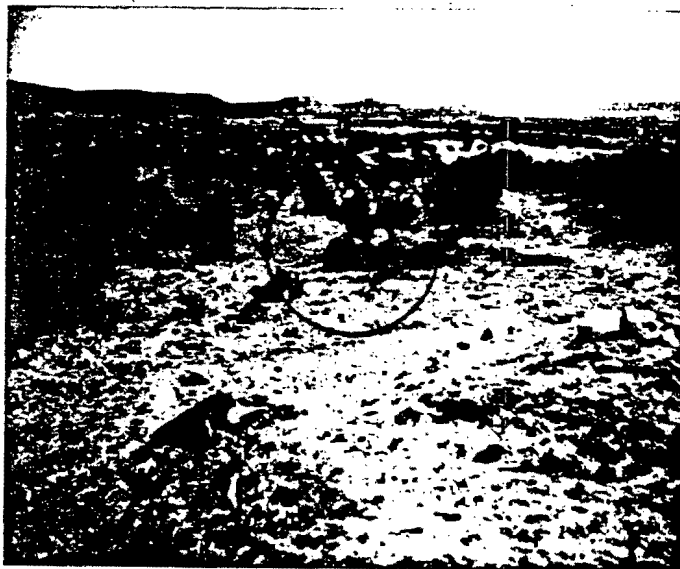
T<sup>H</sup> F.R.

Reading: LUCLUM#19-24uR.hr<sup>-1</sup> :: ESP-II - 2.2(104)

7. DESCRIPTION TRENCH CUT NNE OF B. VANDEVER RESIDENCE  
LOOKING NE. NOTE FRAMES 8, 9, 10 TAKEN AT SAME LO-  
CATION

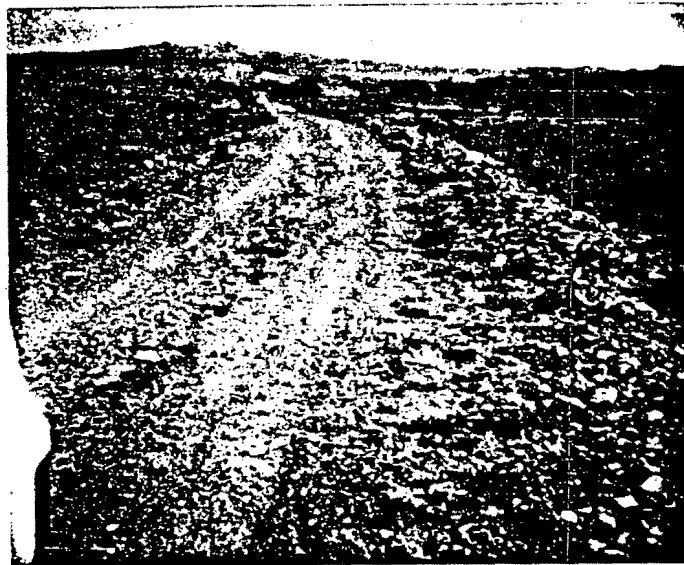
22-11-90

Reading: 105cpm (ESP-11) @ EDGE OF ROAD

7. DESCRIPTION "HOT ROAD" WEST OF B. V. RESIDENCES, SUR-  
FACE WORKS WASTE PILES @ RIGHT MIDDLEGROUND, MT. TAY-  
LOR @ UPPER LEFT BACKGROUND AS REFERENT

- \* The Navajo Superfund Office FIT digilert alerted (enabled) inside the vehicle being used for reconnaissance at one point along the "Hot Road" (3; Frame #22): enable/alert on the device is set at .098 mR.hr-1.

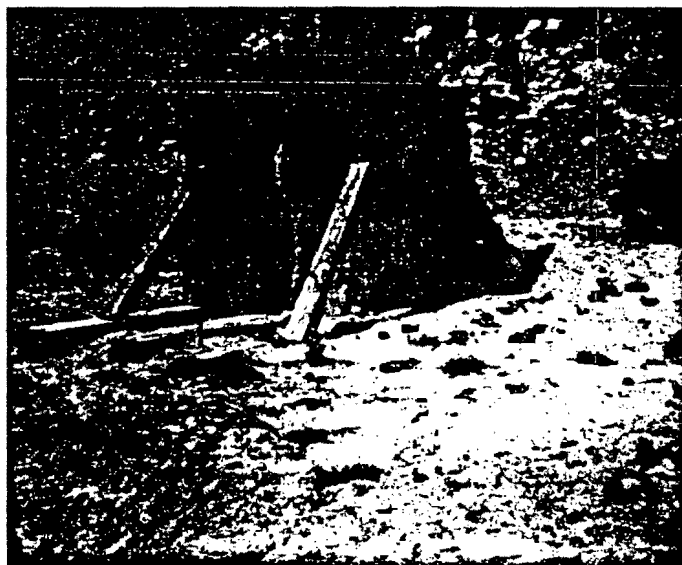
332 ER.

Reading: 10uR.hr<sup>-1</sup> (LUDLUM#19), 10<sup>4</sup>cpm(ESP-II) @ WEST  
FACE OF SHACK

7. DESCRIPTION B. VANDEVER TIMBERED SHAFT, SHAFT AT AN IN-  
CLINATION OF 10° FROM VERTICAL, CIRCULAR APERTURE  
ON S FACING WALL IS WIRED OVER BUT WIRE IS EASILY  
REMOVED, SHAFT ASPIRATES, "300 FT. DEEP" B. V. TO

- \* The timbered shaft retains a shack at its mouth, however, access to the shaft can easily be gained by removing a wire grate covering the portal (3; Frame #33). Additionally, the shaft "aspirates" under certain meteorological conditions, contributing to the area Radon burden.

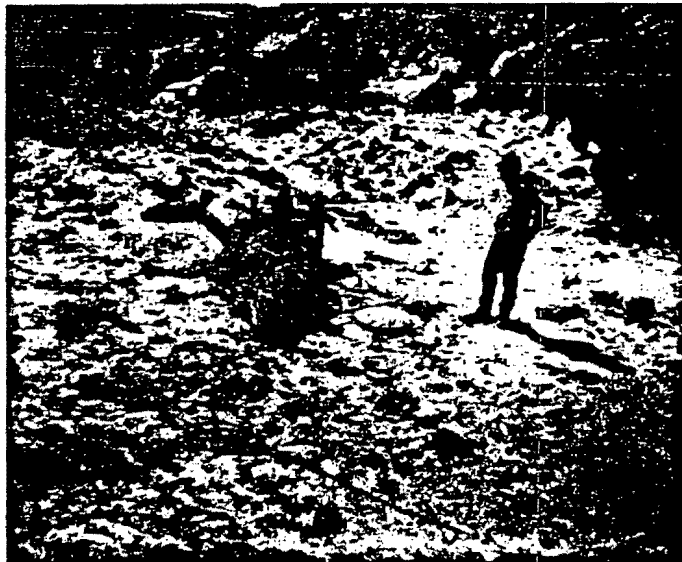
33<sup>rd</sup> FR.  
 (VENT. SHA. VERTICAL !)

7. DESCRIPTION VERTICAL VENTILATION SHAFTS(2), HOSTEEN  
BROWN VANDEVER AT RIGHT MIDDLEGROUND, SHAFTS "300  
FT. DEEP" - B. V. TO P. MOLLOY, APRIL 11, 1990, LOOK-  
WNW

- \* The vertical ventilation shafts are poorly capped and young children in the area could easily gain access to the excavations (3; Frame #33).
- \* One inclined adit is used for waste disposal (3; Frame #12).

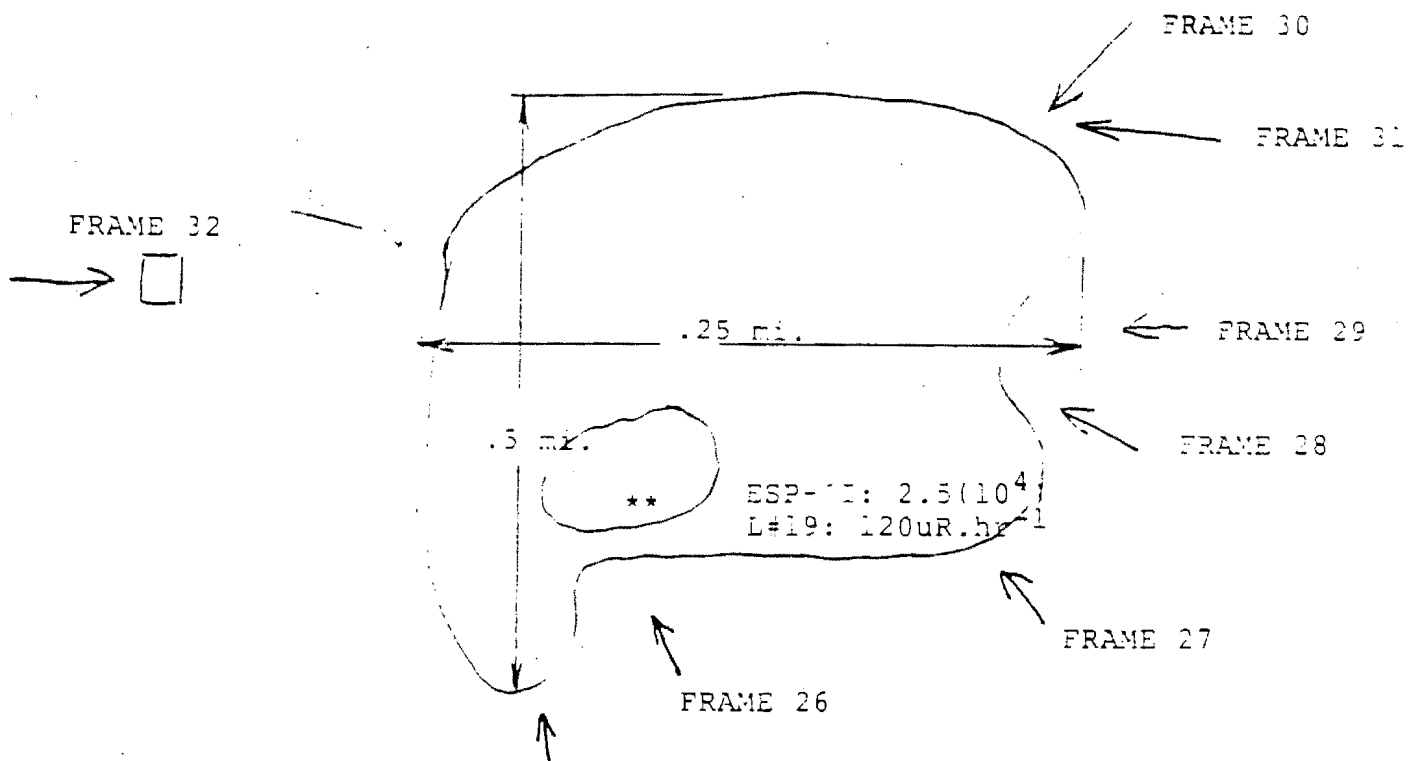
FRAME 25 \* RADIOMETRIC READINGS ASSOCIATED  
 WITH FRAME 27  
 7. DESCRIPTION SKETCH OF AREA WHERE RADIOMETRIC READINGS  
WERE TAKEN, NO SCALE

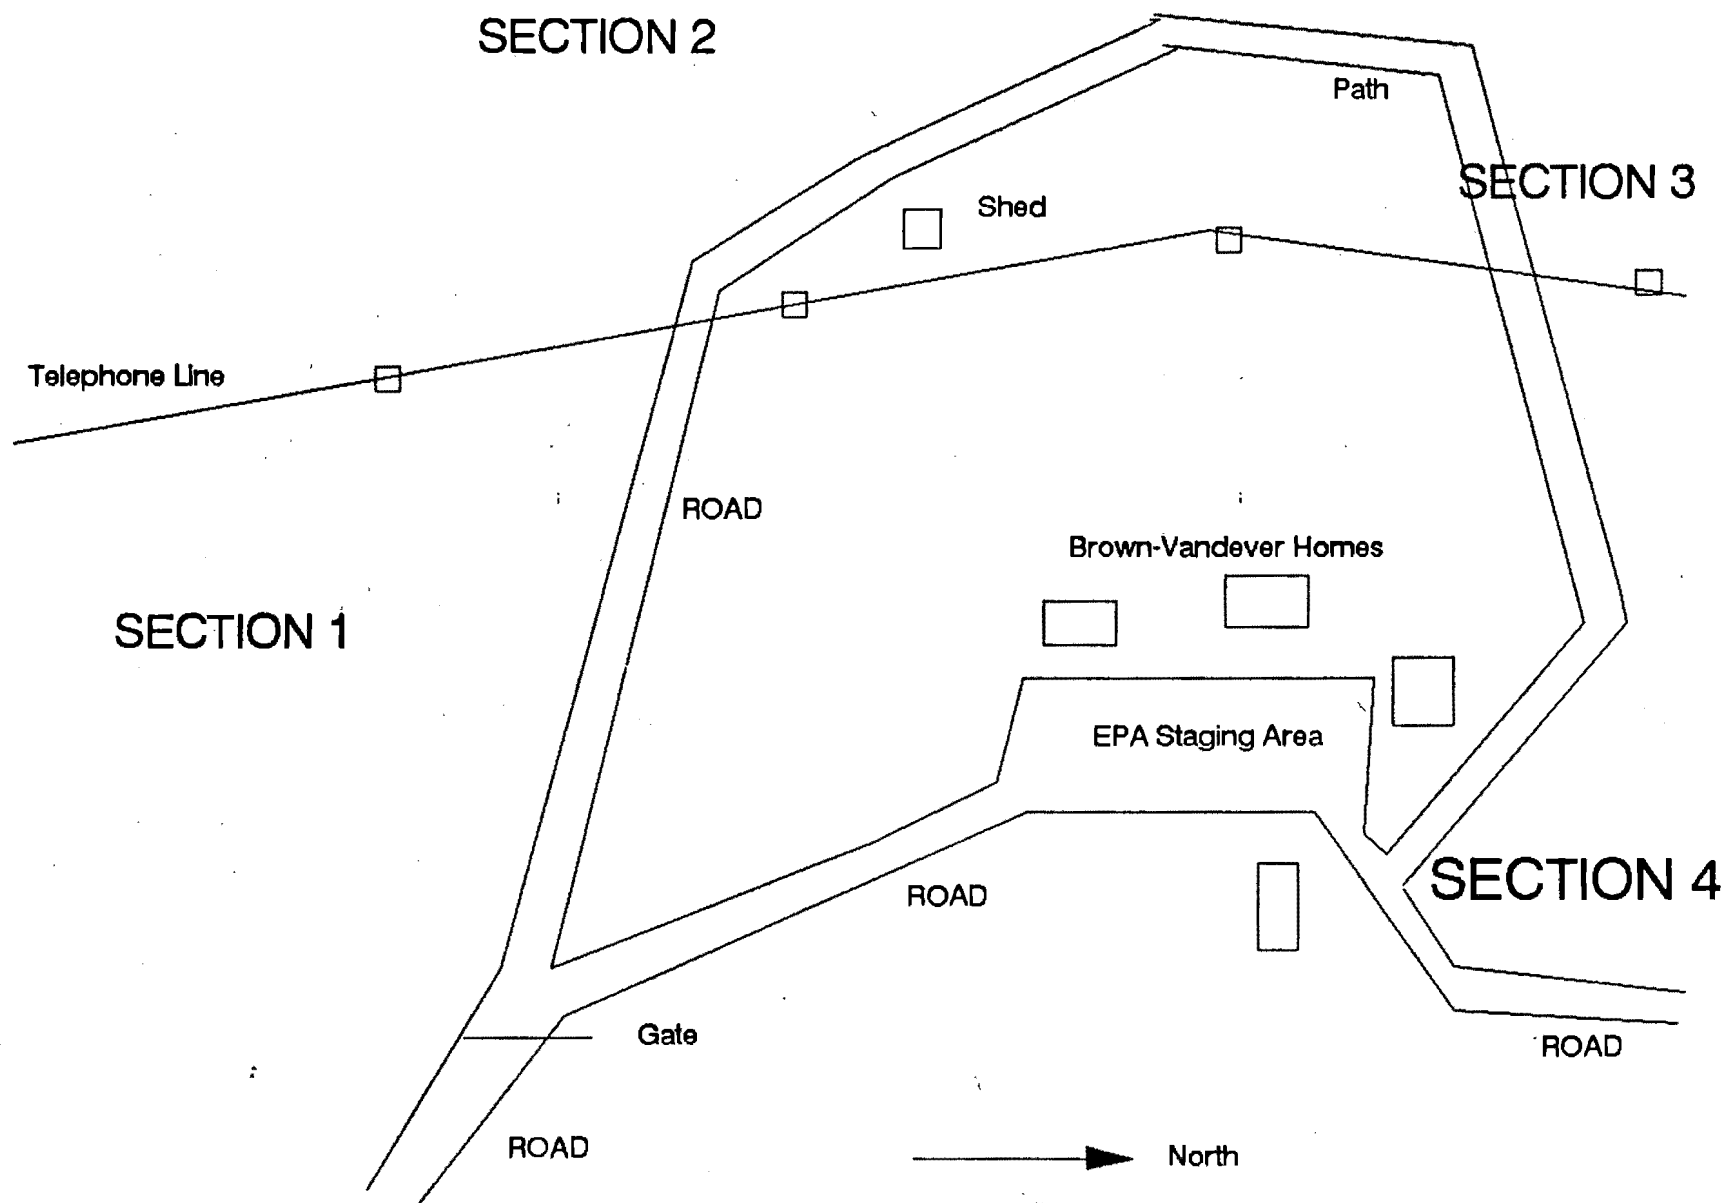
# SAMPLING SECTION LOCATIONS, BROWN-VANDEVER MINE SITE

EPA SURVEY, NOVEMBER 1990

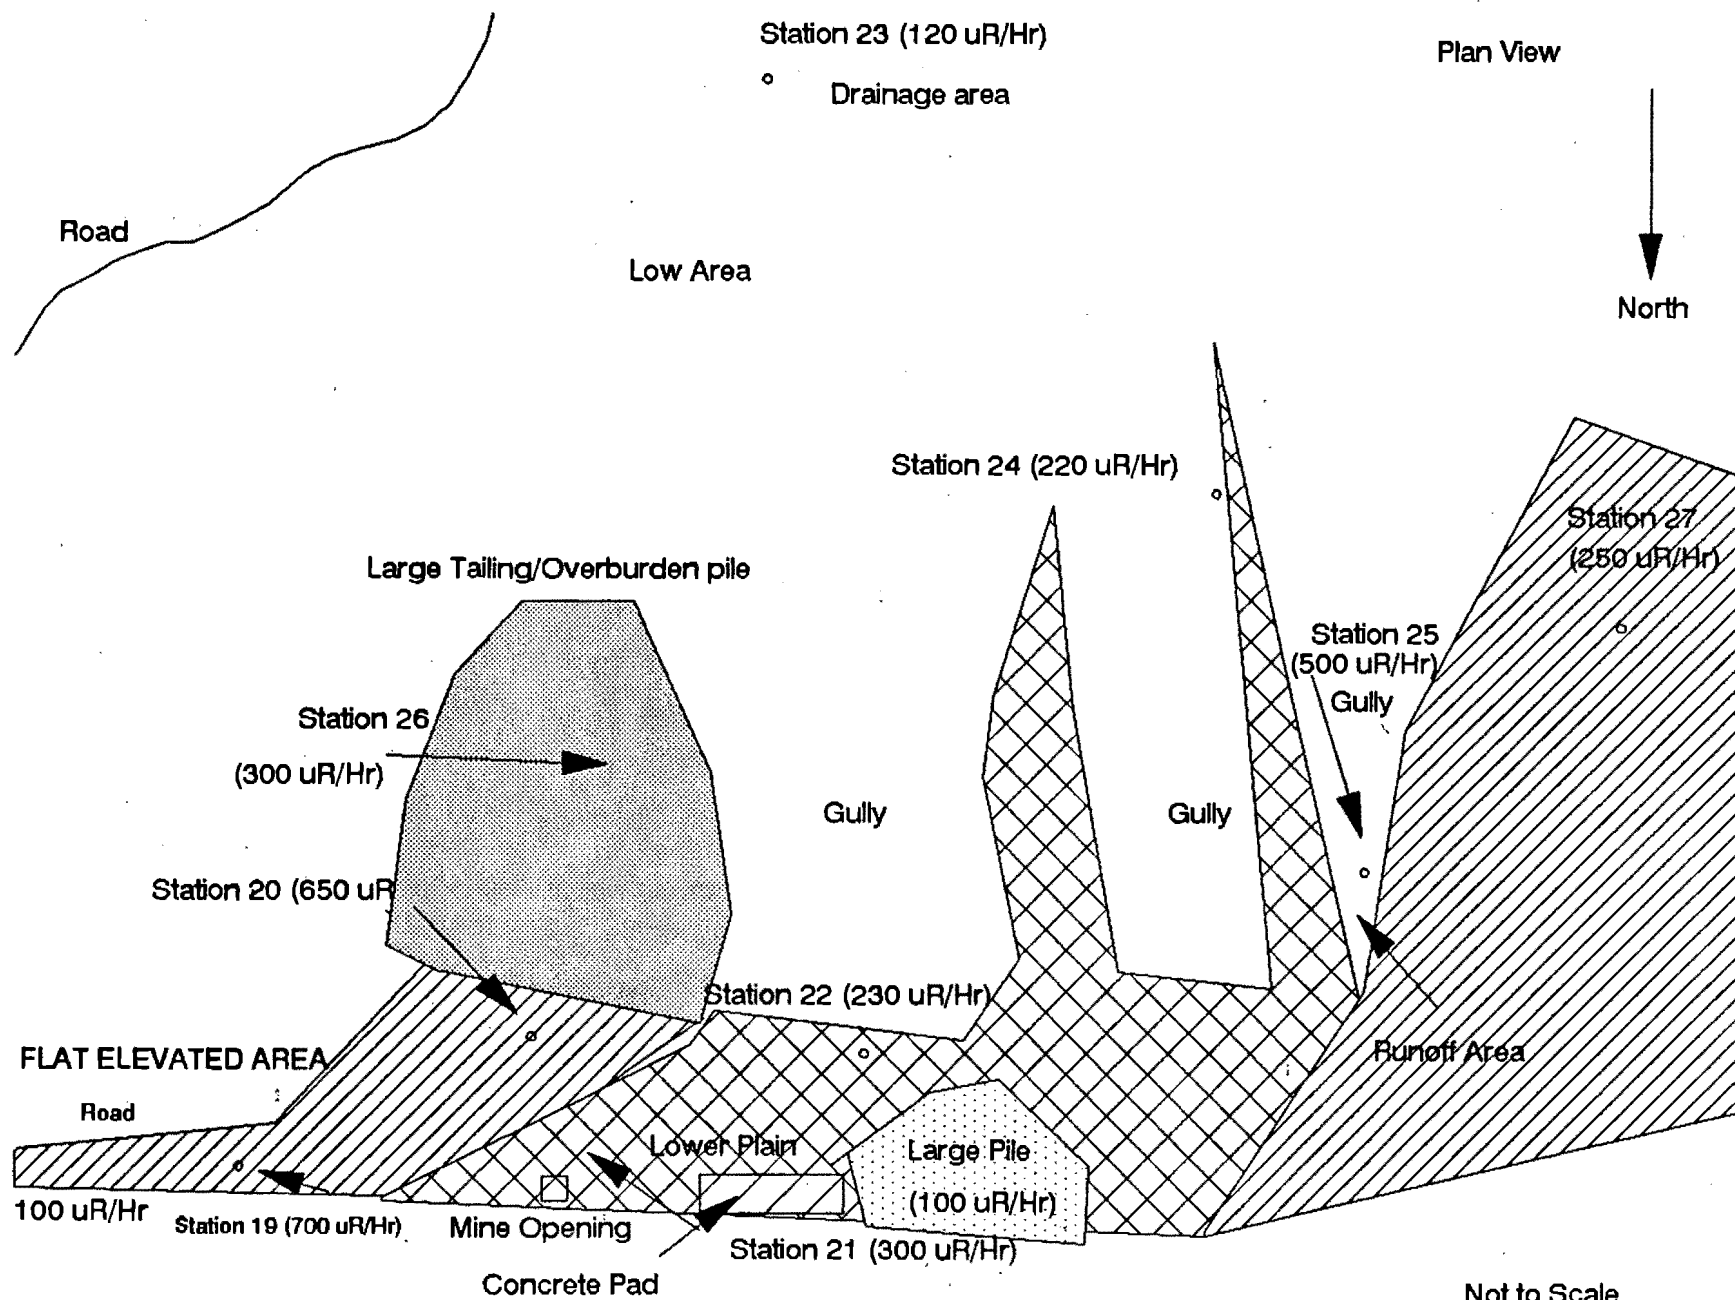
Figure 6. Section 2 B-V.

# SAMPLE LOCATIONS, BROWN-VANDEVER MINE SITE

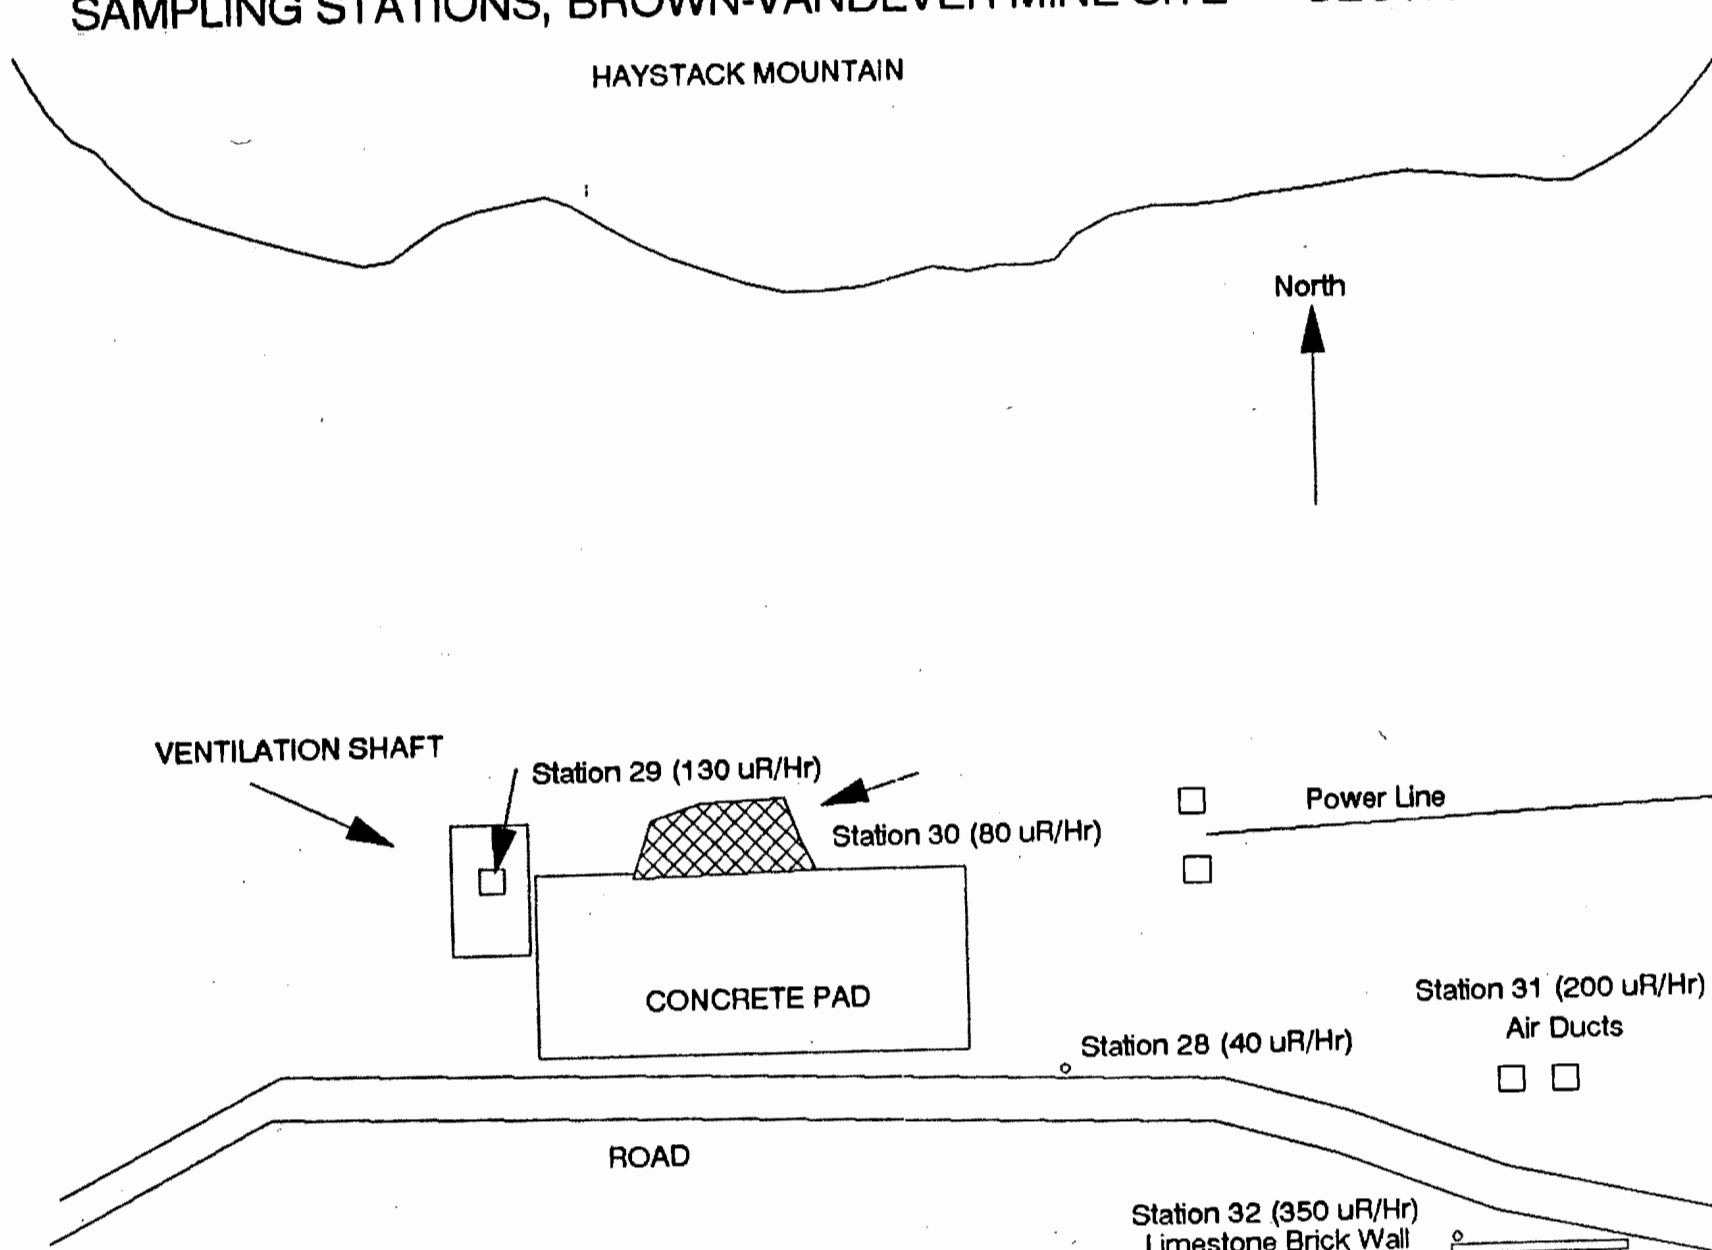
Figure 7. Section 3 B-V.

# SAMPLING STATIONS, BROWN-VANDEVER MINE SITE SECTION 3

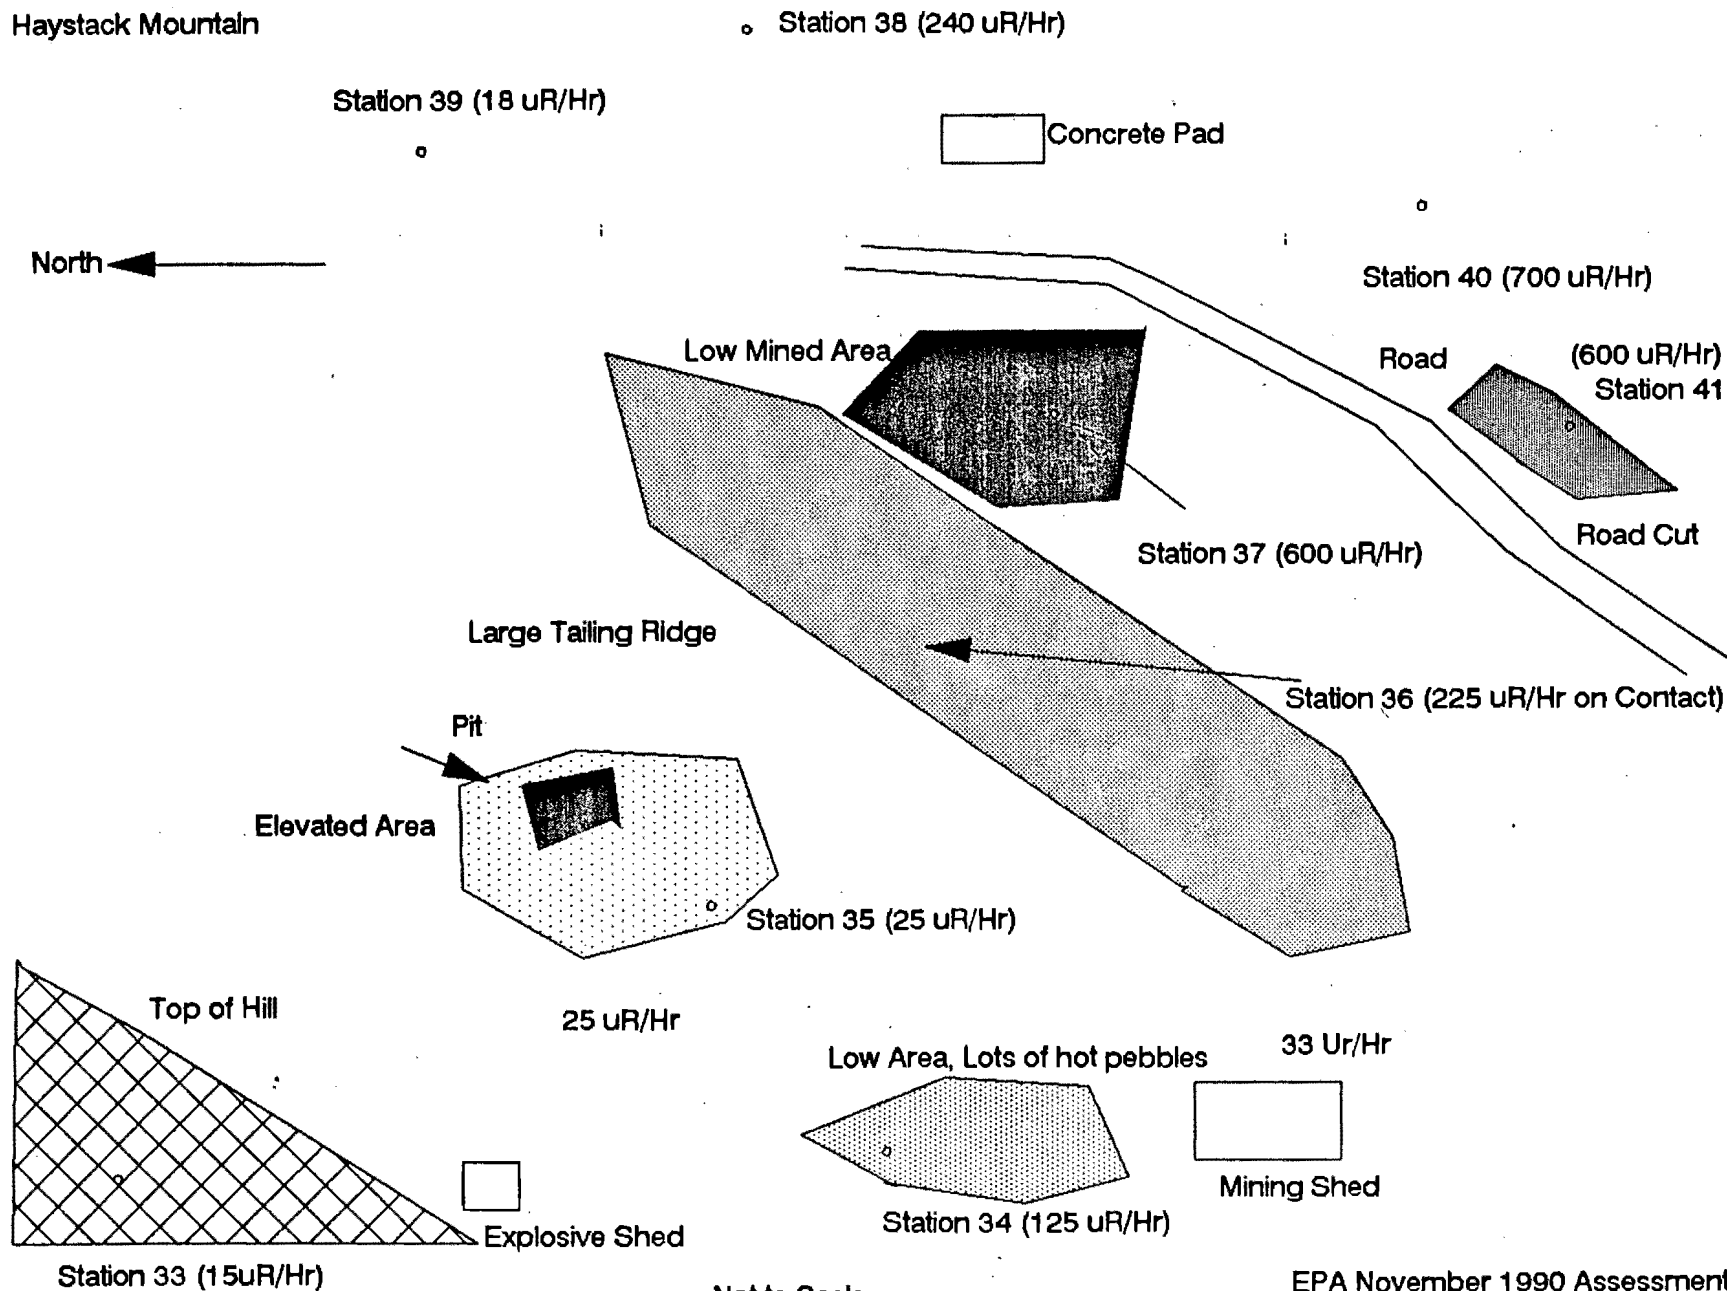
EPA November 1990 Assessment  
Figure 8. Section 4 B-V.

# SAMPLING STATIONS, BROWN-VANDEVER MINE SITE SECTION 4

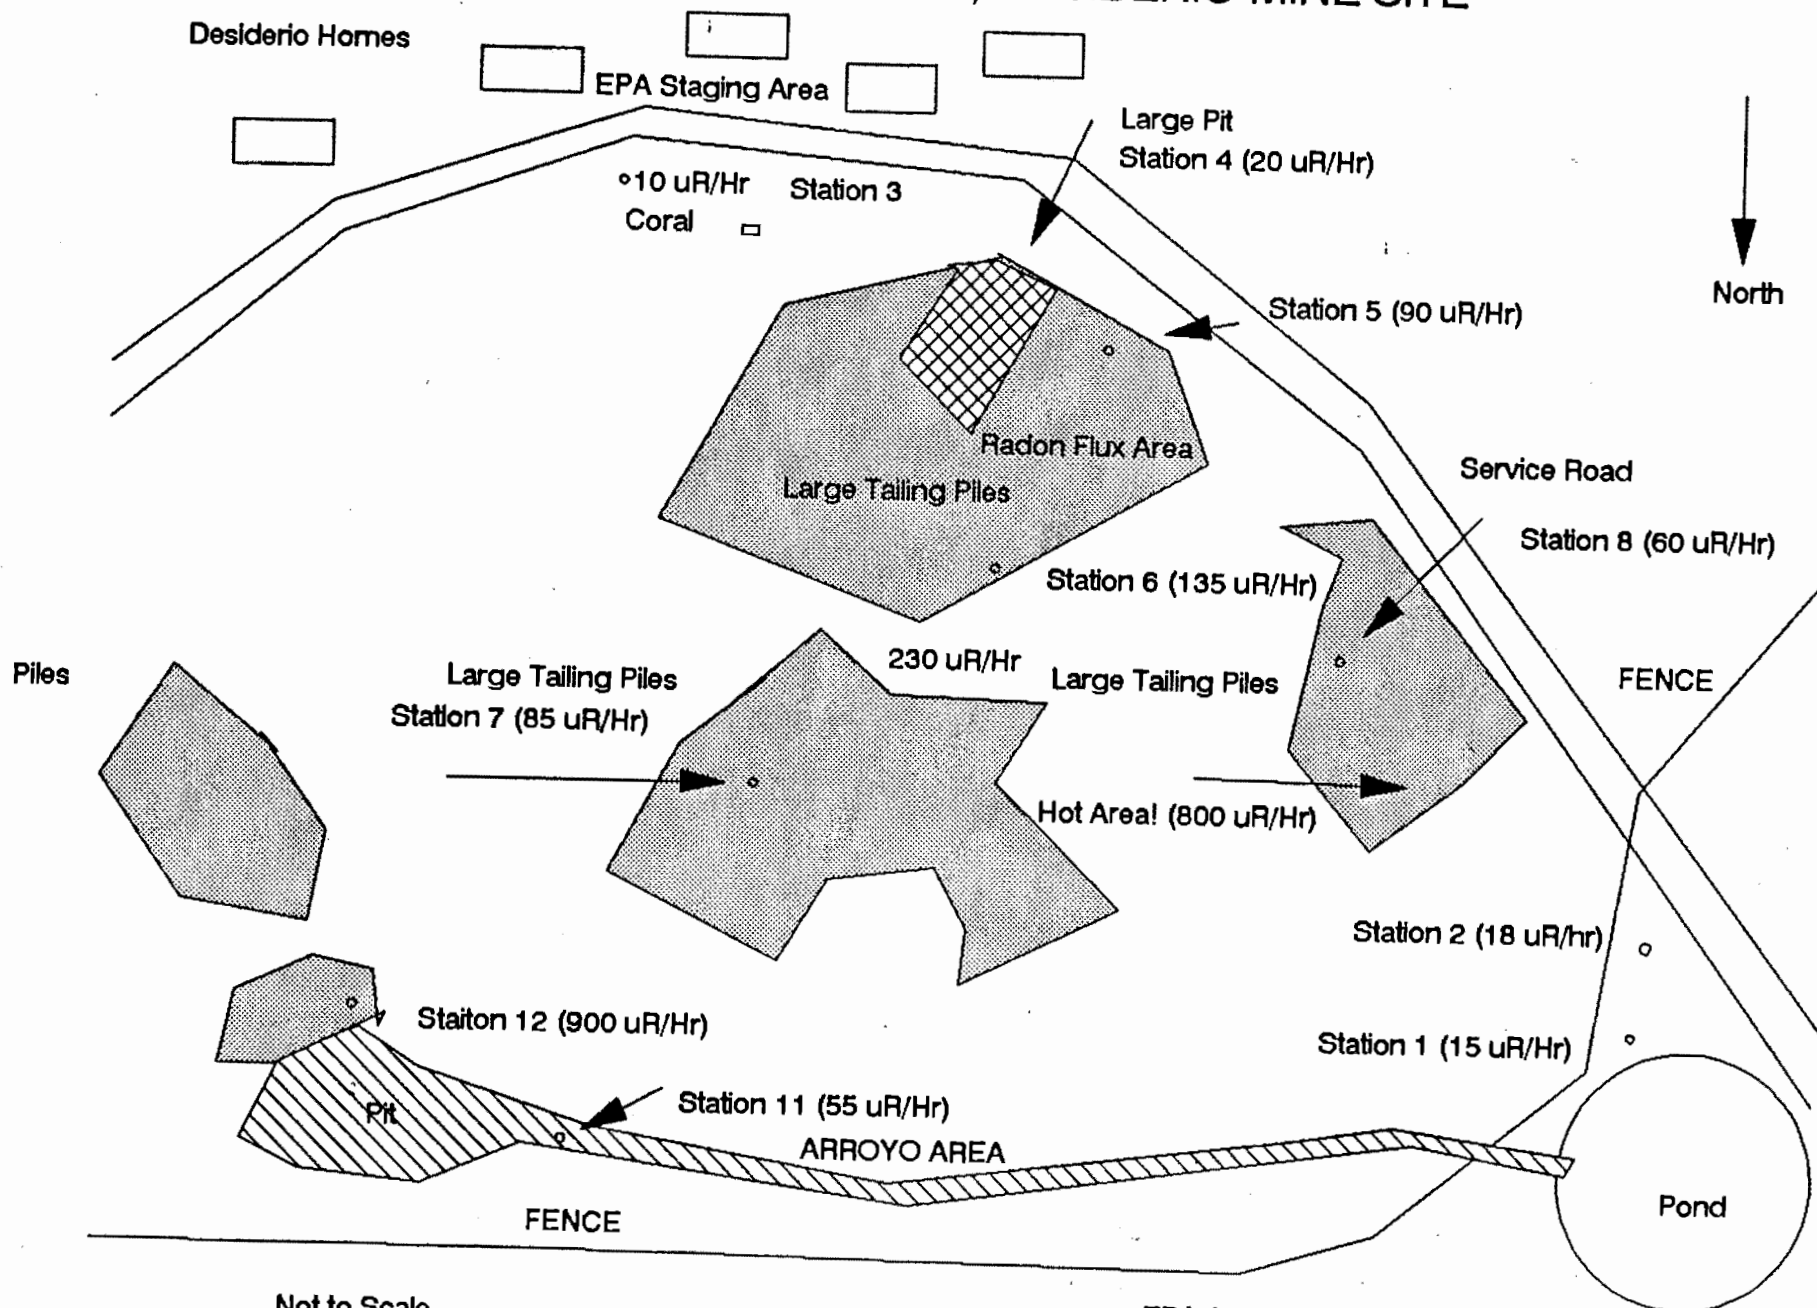
EPA Assessment November 1990  
Figure 9. Desiderio Mine Site.

# SAMPLING STATIONS, DESIDERIO MINE SITE
